Assessment of Cracks on a Building at Tarkwa in Ghana with Respect to Foliations and Joints in Foundation Tarkwaian Rocks

This study was conducted in January, 2007 on the old Ghana National Fire Service building near the Tarkwa Railway Station before it was pulled down to reconstruct a new structure. The work was intended to come out with factors leading to development of cracks in the building. It involved identification, classification and orientation of cracks which were plotted on rose diagrams and compared with foliation and joint orientations in nearby Tarkwaian conglomerate outcrops.

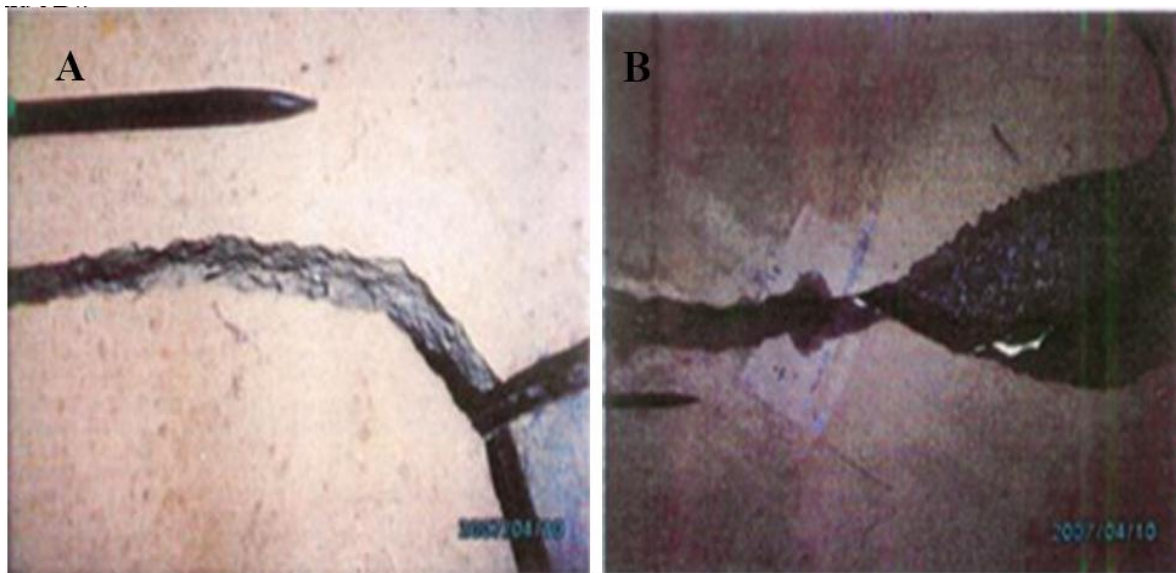
The cracks identified on the walls which did not show any displacement between the horizontal and the vertical were described as syn-horizontal and vertical cracks (Fig. 1A). The horizontal crack on the southern part of the building might have widened up to about four times its width (Fig. 1B). Diagonal cracks were common and were probably stopped and later reactivated or offset by vertical cracks (Figs. 2A and 2B). At a corner of the wall, occurred a vertical crack which might have changed into horizontal cracks in the wall (Fig. 3A). Peeling was more extensive in diagonal and horizontal cracks which were wavy (Figs. 2A and 3C). Thus three generations of repeated or reactivated cracks occurred in the walls – the first had extensive widths with significant peeling (Figs 1-3); second generation cracks had limited opening (Figs 4A and 4B); whilst the latest had narrow widths (Figs. 5A and 5B).

Figure1. Photographs of horizontal cracks on walls showing *a) syn-horizontal and vertical crack relationship and b) widened crack.*

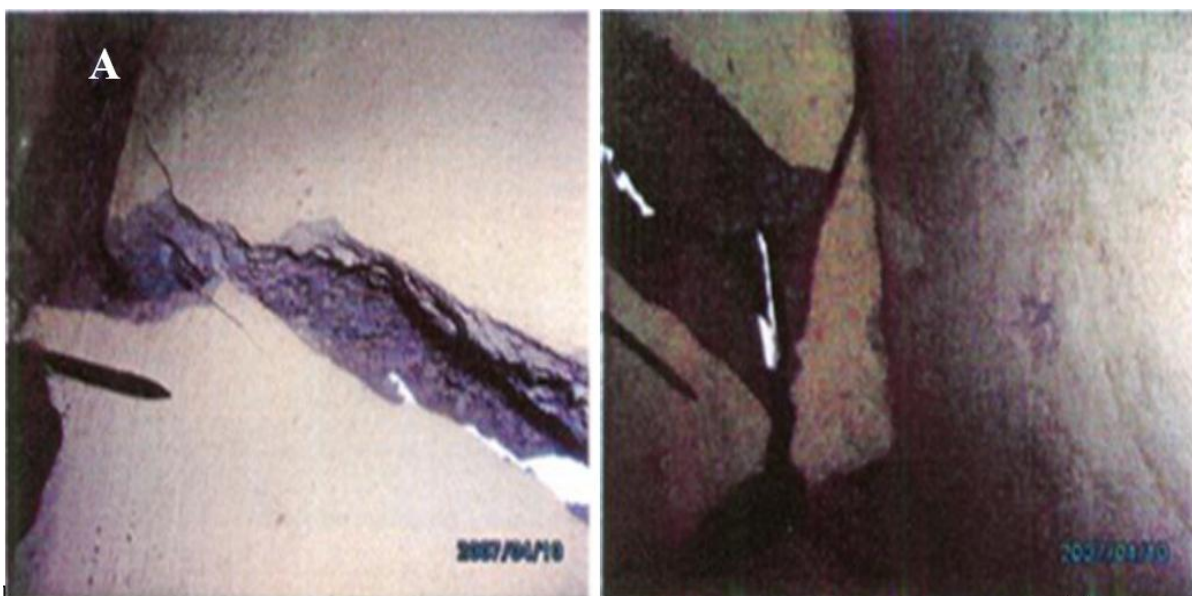
Figure2. Photographs of Diagonal Cracks showing *a) Reactivation by later crack and b) Offset by Vertical Crack*

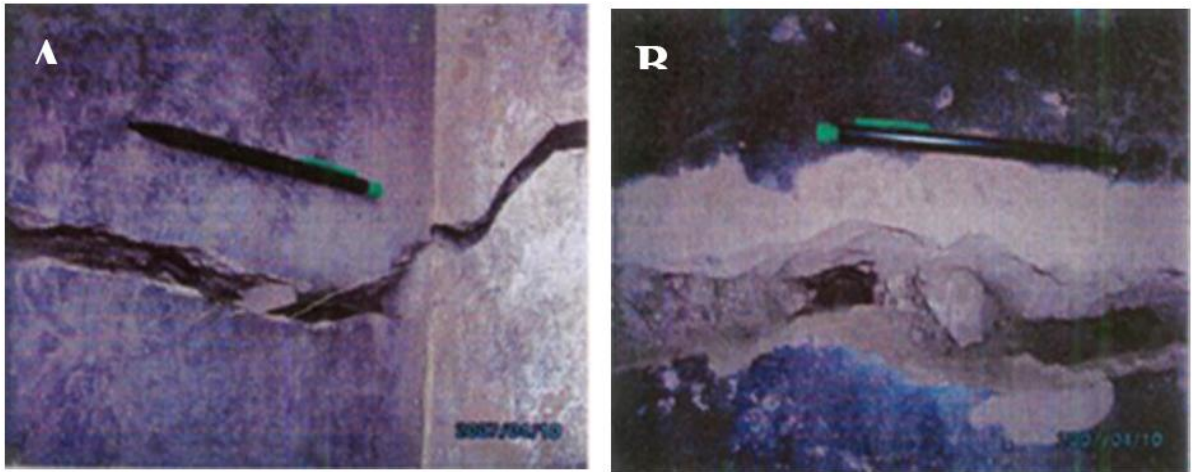
Figure3. Photographs of Cracks on the floor at the southern part of the Building showing a) Horizontal crack in the east developed into Diagonal Crack at the west b) Horizontal crack

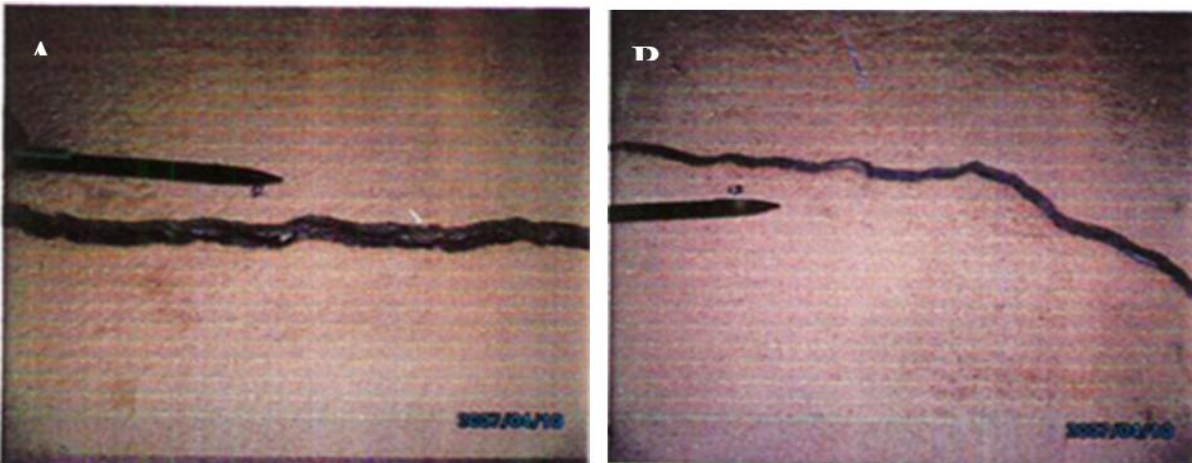
Figure4. Photographs of Second Generation Cracks on Walls with limited opening showing a) Wavy Horizontal Crack and b) Wavy Horizontal Crack migrating into Diagonal Crack

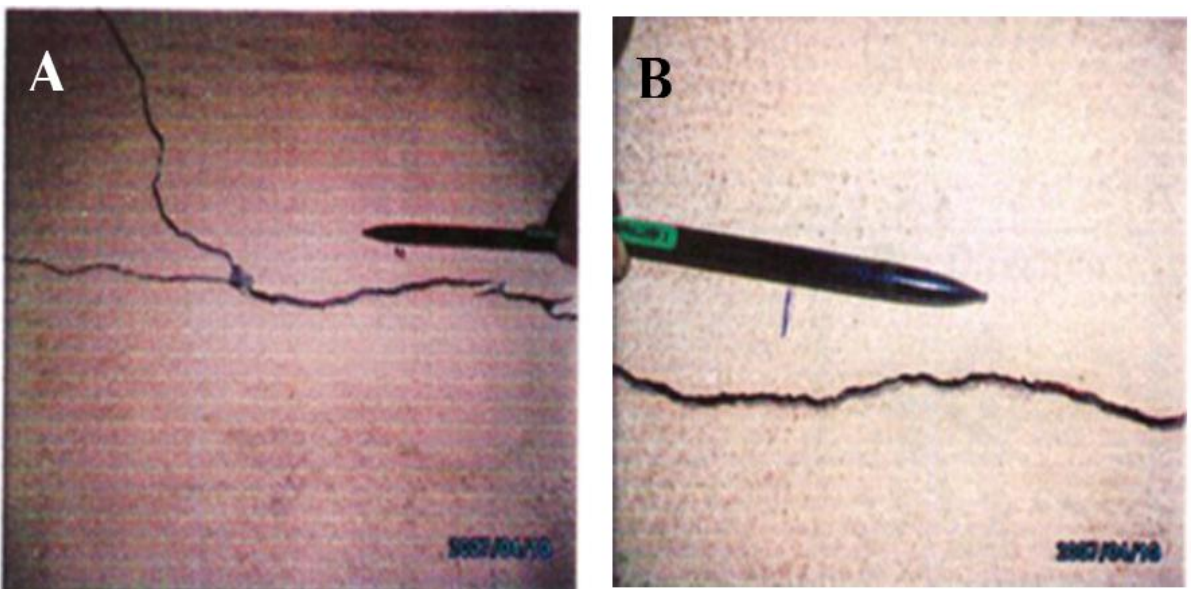
Figure5. Photographs of Cracks on the western part of the Building showing a) Vertical Crack taken over by a Horizontal Crack b) Wavy Horizontal Crack

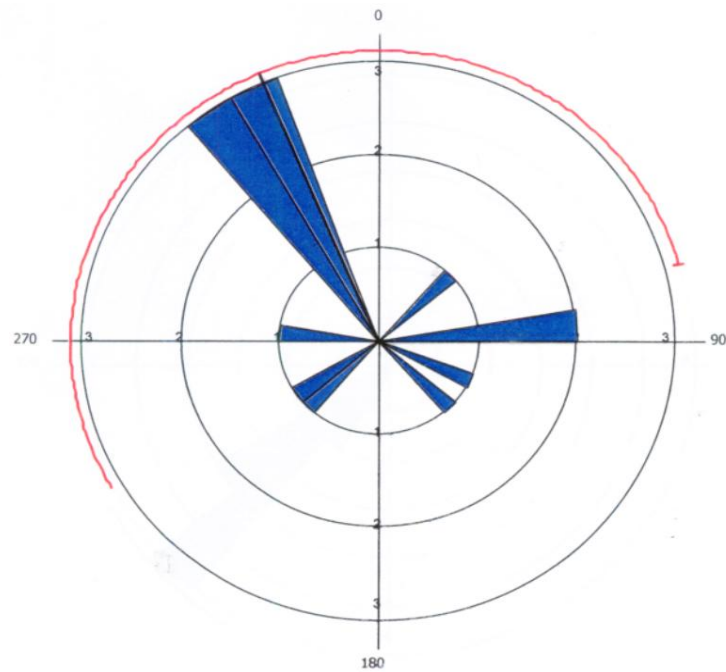
Figure6. Rose Diagram of Cracks on the Ghana National Fire Service Building showing main NW and minor E directions ($N = 14$).

Strike directions of the cracks on the building, however were mainly to northwest with minority to the east (Fig. 7). Most of the cracks were horizontal to nearly horizontal with vertical displacement near the bottom of the wall. According to Anon. (2011) these types of cracks resulted from great load or

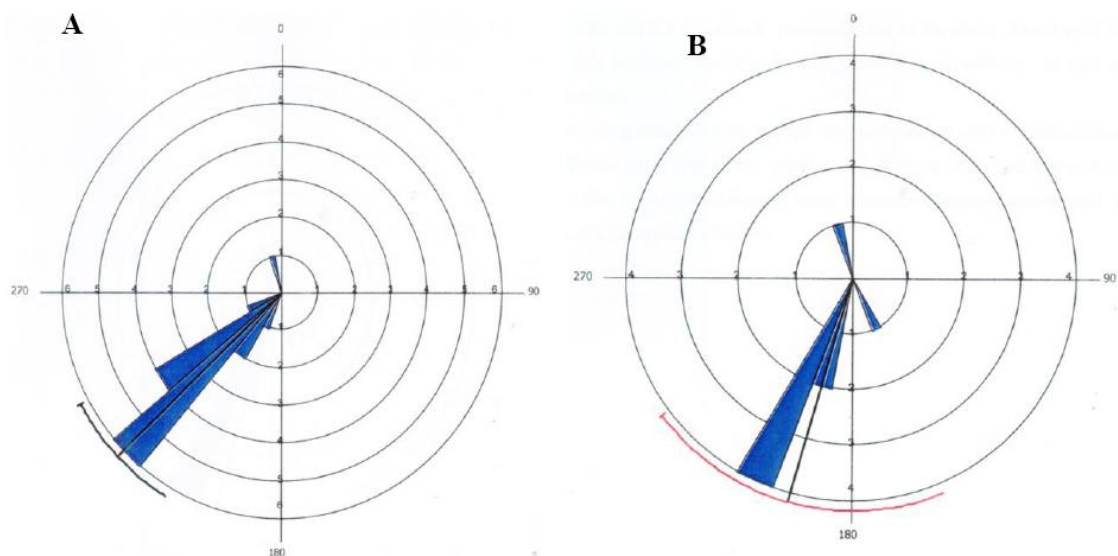
Figure7. Rose Diagram of structural measurements in the Metaconglomerate/Quartzite at the Mining Pit and Outcrop showing A) Foliations strike mainly in SW direction ($N = 15$) B) Joints strike mainly in SSW direction ($N = 8$).

pressure that was placed on the foundation beyond the bearing capacity to cause settling of the structure. Cracks on the building strike in a direction different from the joints and foliations in the immediate foundation rocks. Foliations and joints in the outcrops close to the underground mine strike mainly in south-southwest direction and dip moderately at about 50 degrees (Table 2, Figs. 8A and 8B).
