## Application of a Channel Stability Assessment Method near Bridges and Culverts: Case Study in Parana State, Brazil

**Abstract:** This study aims to evaluate the level of stability of river channels in bridges and culverts in two watersheds located in the state of Paraná (Brazil), adopting the methodology of the Federal Highway Administration (FHWA). These watersheds are composed by sandstone of the Paraná River Formation in the Parana Watershed 2 (BP2) and by basalt of the Serra Geral Formation in the Paraná Watershed 3 (BP3). The channel stability level was analyzed in 6 structures in the BP2 and 46 structures in the BP3. All structures located on federal, state and municipal asphalted roads were selected. Among the points analyzed in the BP2, 83% were classified in the Good Level category and 17% in the Fair Level category, while in the BP3, 28% were classified in the Excellent level and 72% in the Good level. In both watersheds, bridges and small bridges presented Excellent and Good levels, while in culverts the Good and Fair levels predominated, showing that the first structures created fewer impacts in the fluvial channels than the culverts. These data illustrate the great

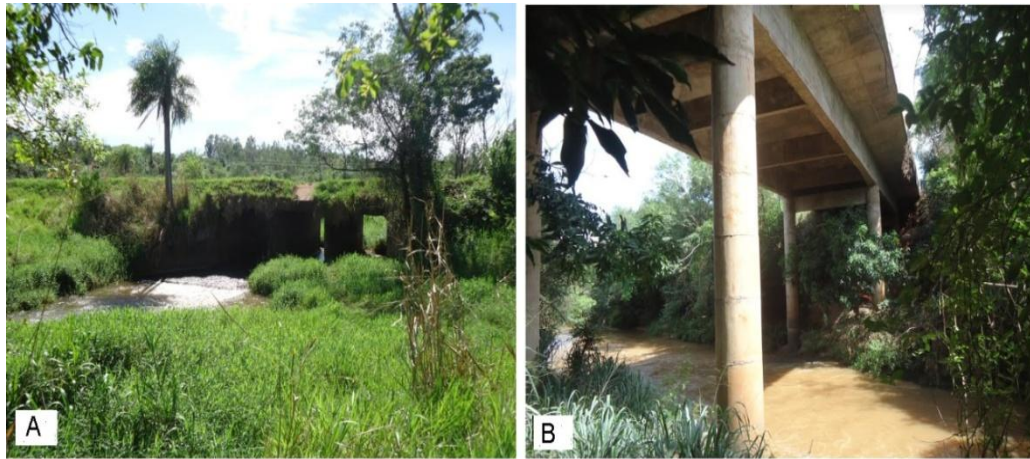
**Figure 3.** Examples of channel stability in the Parana Watershed 2: A) Site 1, Fair; B) Site 5, Good.

The silting of watercourses is most evident in the rivers located in the southern part of the Paraná Watershed 2, where the terrain presents a weak dissection, with wide valleys and well-developed alluvial plains, giving rise to meandering traces (see Figure 3A). This situation leads to high levels of instability, as in the case of Structure 1 (culvert), which sums 89 points (Fair Level). Structures 2 and 3 are classified in the Good level, with 84 and 76 points, respectively, very close to the Fair level, which starts at 85 points. In these three structures, high values of the indicators such as slope of the margin phase, riparian forest width and evidence of marginal erosion are responsible for the high score.

The other points (4-6) are located in the central and northern parts of the Paraná Watershed 2, which show a relief with a medium dissection, a more rectilinear channel trajectory and outcrops of the Paraná River Formation in channel beds, which have a low degree of entrenchment (see Figure 3B). These conditions provide Good stability indexes, with scores around 50 points (Table 3), already close to the Excellent level, whose score is equal to or less than 48 points.

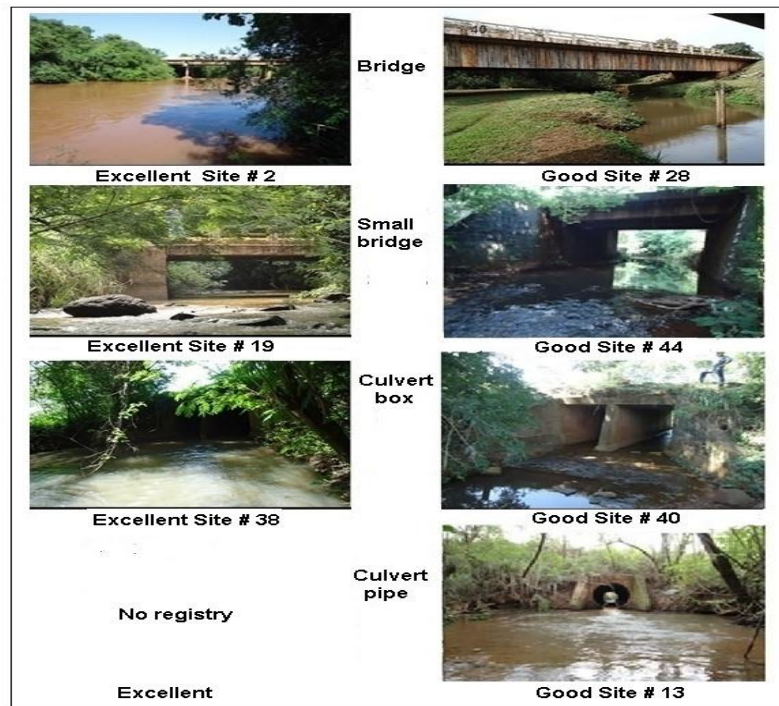
Among the 46 devices surveyed, 33 were classified in the Good stability level and 13 in the Excellent level (Table 5). Some examples of devices with respective stability levels are shown in Figure 5. It should be noted that there was no record of any structure with Fair or Poor channel stability levels.

Figure 5. Examples of channel stability in the Parana Watershed 3
