Artifacts in Cone Beam Computed Tomography Imaging Mimicking a Dental Fracture in Unfilled Root Canals: A Case Report

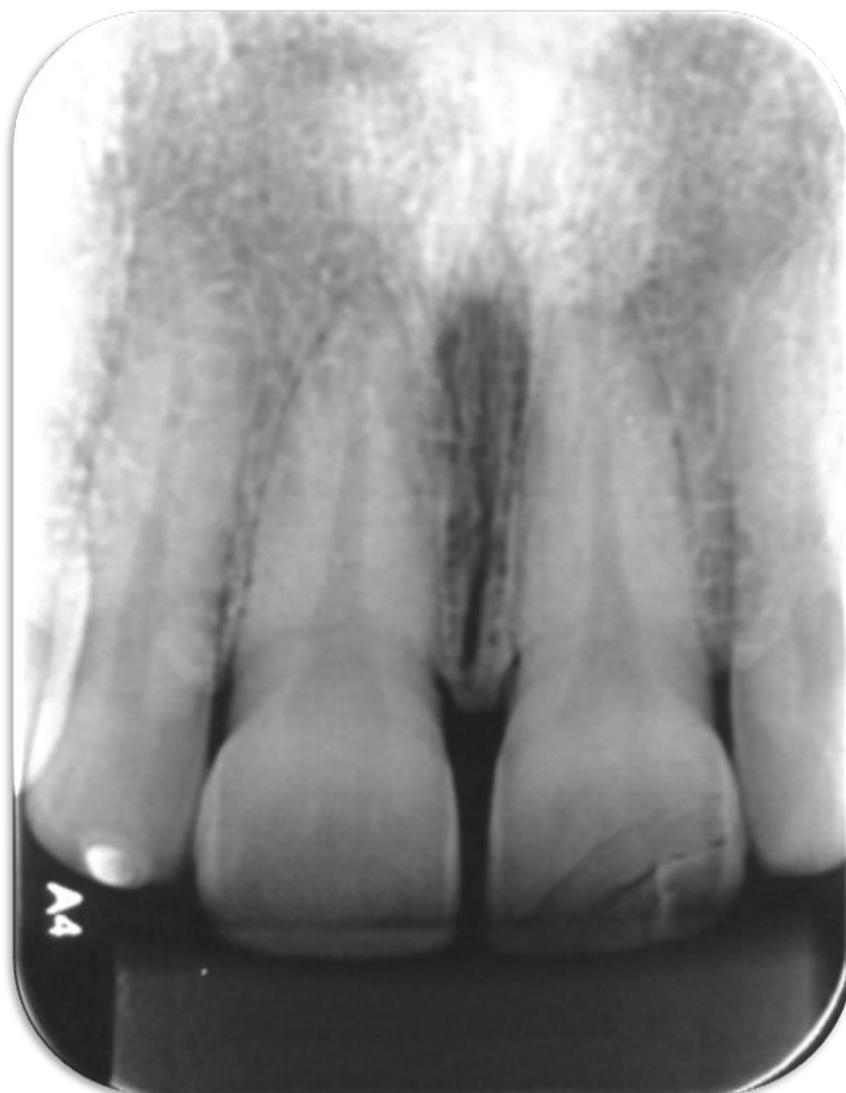
A 27-year-old woman was referred to a private clinic after local trauma during physical activity. The patient did not have pain or other complains, and her medical history was not contributory. The dental status was satisfactory, being noted on the right lateral incisor, the presence of a dental piercing: a piece of jewelry applied on the vestibular surface of the crown. Clinical examination revealed oblique crown fracture in the middle third of the left maxillary central incisor involving enamel and dentin without exposure of the pulp. The treatment was reattachment of the tooth fragment. However, after one month, the patient returned to the clinic complaining about severe pain. The vitality pulp test was performed and the tooth had a positive response. In the periapical radiograph, no signs of root fracture or periapical pathology were observed (Fig. 1).

Fig1. *Periapical radiography showing no signs of root fracture*

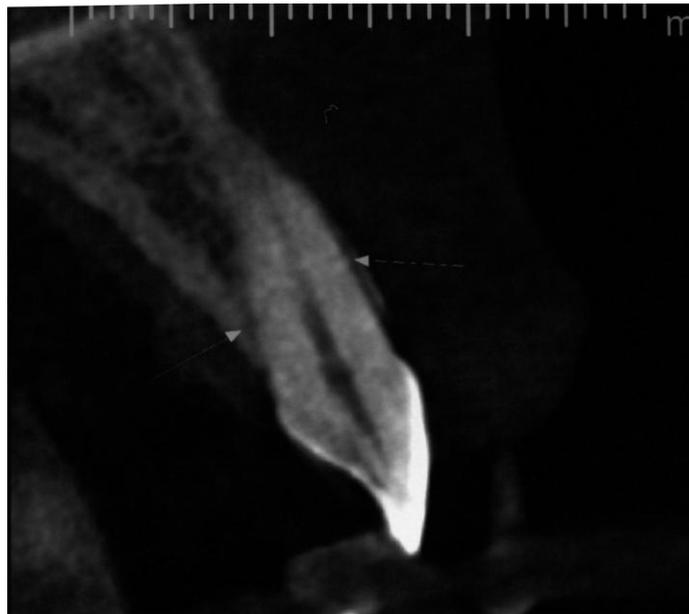
The patient underwent CBCT examination (Eagle 3D CBCT unit; Dabi Atlante, São Paulo, Brazil) in order to evaluate the possible presence of periapical lesion or root fracture. During the image observation, it was detected in the sagittal view, a hypodense line in the middle third of the root, buccal-palatal oriented, suggesting the presence of root fracture (Fig. 2).

Fig2. *Sagittal CBCT slice showing the possible fracture in the middle third of the root (white arrows).*

In some cases, false-positive diagnosis can occur in CT or CBCT images acquired for root fracture diagnosis. This may happen due to artifacts obscuring the tooth root. In the case reported, it was possible to clearly observe the hypodense line in the root on CBCT images; however, no fracture was visualized in visual inspection after the extraction of the tooth. Consequently, it was possible to conclude that the hypodense line was a beam hardening artifact, despite the fact that the tooth and adjacent teeth did not have any intracanal materials, which would justify the formation of the artifact due to the high densities of the objects.

It is hypothesized that the artifact present on the image was originated from the dental piercing placed on the right maxillary lateral incisor, which could explain the hypodense line in the image. Another point that supports this hypothesis is the second CBCT examination that was acquired when the patient no longer had the dental piercing and does not present any hypodense line, this artifact or assumed fracture was not visualized.

The treatment of choice was extraction of the tooth and immediate dental implant placement. After the extraction, the tooth was visually inspected and no root fracture was detected. For this reason, the tooth was replanted into the alveolus and a semi-flexible splint was used during seven days.

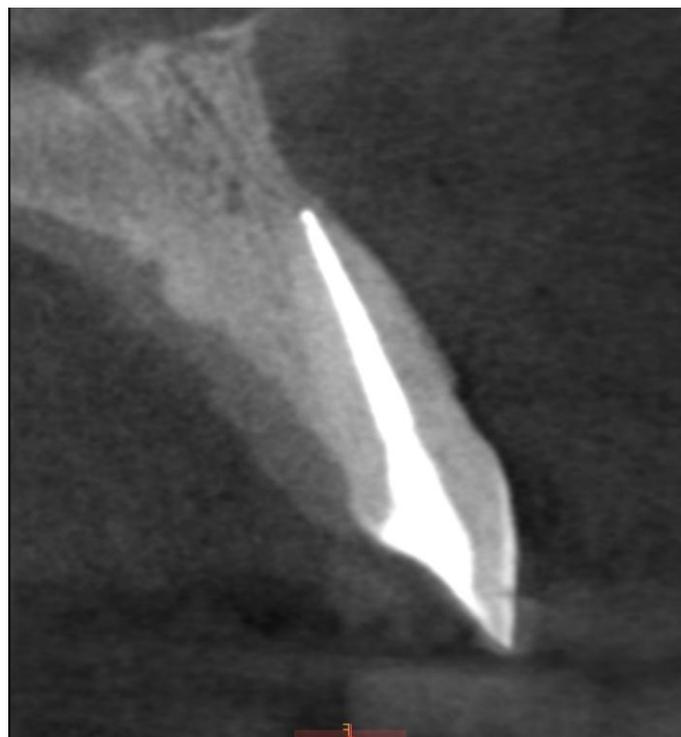
A 03-year follow-up was performed and no complaints were reported. During clinical examination, the absence of the dental piercing was noticed. The patient underwent a second CBCT examination and no signs of root resorption or ankylosis were detected in the tooth (Fig. 3). Additionally, no hypodense line was observed on the images.

Fig3. *Sagittal slice of CBCT image acquired at the three-year follow-up of the replanted tooth showing no signs of root fracture or external root resorption.*
