Expulsion of a Spontaneously Broken Arm of a T- Shaped IUD: a Case Report

Citation: Gulsum Uysal, *Expulsion of a Spontaneously Broken Arm of a T- Shaped IUD: a Case Report*. *ARC Journal of Public Health and Community Medicine*.2018; 3(2):28-30. DOI: [dx.doi.org/ 10.20431/2456-0596.0302005](https://doi.org/10.20431/2456-0596.0302005)

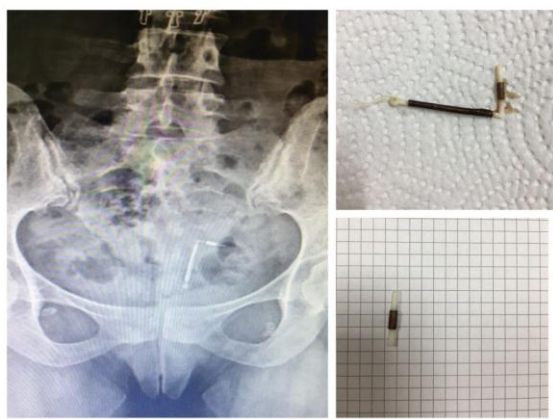
(Figure 1). During her menstruation period she noticed the broken part of the IUD in her pad. Therefore she applied to the clinic to check the localization of IUD. She had neither anormal bleeding symptoms nor pelvic pain. She had soft abdomen, with normal vital findings (afebrile, 120/80 mmhg). She had an Copper T A380 IUD, inserted three and a half year ago during lactation. Her last birth was cesarean section nearly 4 years ago. She had one normal delivery and two cesarean section. This IUD was her second use in her reproductive family planning life. She was pleased with this contraception method. Her body mass index was 22 and had no chronic disease or drug use.

In her per-speculum examination there was no thread of IUD. Following ultrasonography examination an in situ uterine cavited IUD was seen. The position of the uterus was anteverted (cervix angles forward) anteflexed (body is flexed forward) with endometrial thickness of 6 millimeters. An X-ray of her abdomen was performed and finally copper-T was revealed in the pelvic area of her abdomen with the shape of one side broken frame IUD (Figure 1).

Figure1. Part of broken frame, shape of one side broken frame IUD in pelvic x-ray and IUD after removal

After her informed consent removal of IUD was planned. The one side broken frame IUD was removed successfully by GU with the help of a alligator forceps without anesthesia in gynecology clinic (Figure 1). There was no complication. The patient did well and was sent home at the same day.

One explanation for the breakage could be an initial stress fracture to the frames of IUD during insertion[9]. Moreover, rhythmic uterine contractions and menstrual bleeding at the time of her period might have been an additive stress on the frames of the IUD which probably led the breakage and self-ejection of one arm of the IUD. The patient was lucky to realize the broken part. Unnecessary research and treatment such as hysteroscopy or even laparoscopy could be needed to find the broken part. This would also cause the surgeon anxious as to where the broken part of the IUD was.
