## **Relation of Riverbank Erosion With Agricultural Landuse Practices on Floodplain of River Jaldhaka (Mansai) at Tikiner Char, Bhowerthana Village, Coochbehar, Westbengal, India**

**Tapas Barman**

Researcher, M.A. in G.U., B.Ed in M.D.U  
[barmantapasg@gmail.com](mailto:barmantapasg@gmail.com)

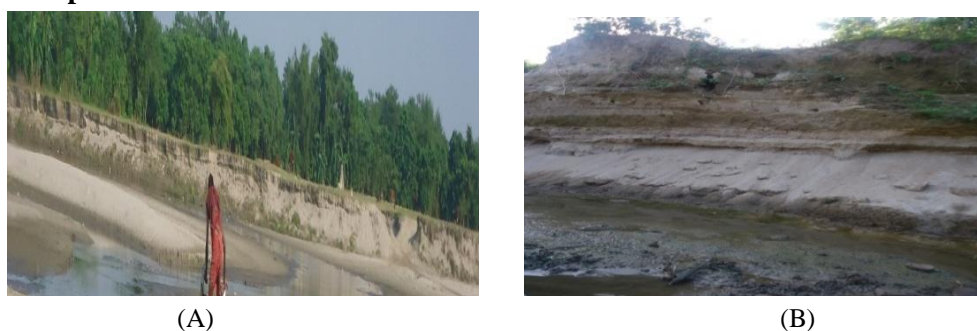
Plate6 (A) & (B). River bank composition at the western part of the floodplain (char).

Bank composition perhaps is the most important concern in the present study. In fact, reach scale differences in bank erosion rate suggested serious bank stratigraphic significance. In relation to bank composition time is also a dominant factor of controlling bank erosion rate. In observation, the rate of bank erosion is 2 times more in eastern part then the western part of the study area.

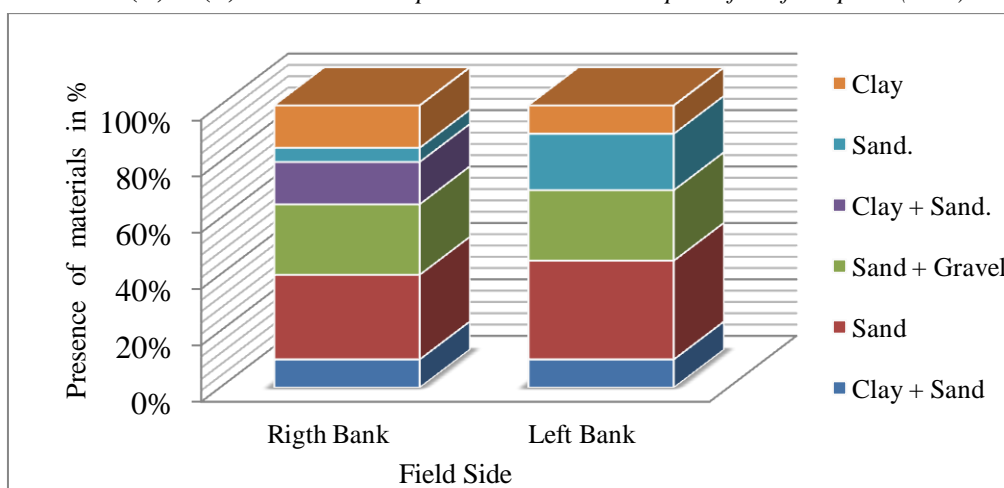
Chart1. Showing the composition of river bank (both) of Mansai (Jaldhaka) at Tikiner Char.

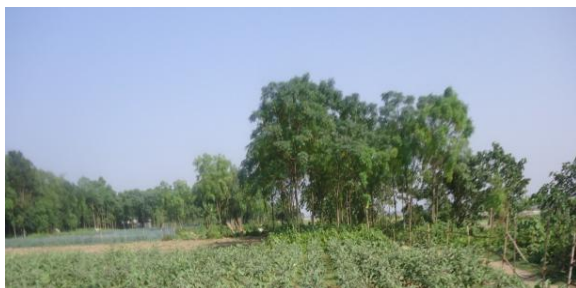
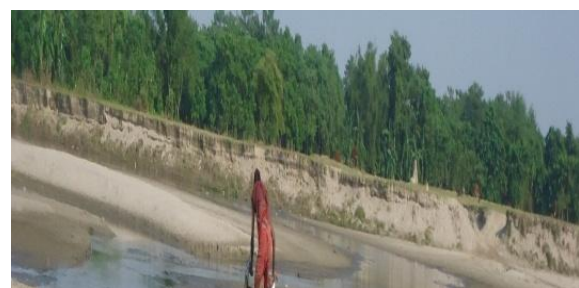
Plate 5(A) & (B). Riparian vegetation

In acts as a protective cover for the river banks which by their root reinforcements binds the bank soils and increase the soil cohesiveness. Perception surveys revealed that most parts of the floodplain (char) covered by some hardwoods (e.g., Khayer, Shisuk, nim etc) trees and different kinds of grasses which had enhanced the tensile strength of the bank walls and surfaces and thus had protected the banks from erosion earlier even during peak monsoons. With time, agricultural expansion towards the river is aggressively replacing the bank vegetation to different kinds of crops and vegetables. In 1995 to 2010 around 20% to 30% natural vegetation area have been converted into croplands and human settlements.
