## Application of a Channel Stability Assessment Method near Bridges and Culverts: Case Study in Parana State, Brazil

**Abstract:** This study aims to evaluate the level of stability of river channels in bridges and culverts in two watersheds located in the state of Paraná (Brazil), adopting the methodology of the Federal Highway Administration (FHWA). These watersheds are composed by sandstone of the Paraná River Formation in the Parana Watershed 2 (BP2) and by basalt of the Serra Geral Formation in the Paraná Watershed 3 (BP3). The channel stability level was analyzed in 6 structures in the BP2 and 46 structures in the BP3. All structures located on federal, state and municipal asphalted roads were selected. Among the points analyzed in the BP2, 83% were classified in the Good Level category and 17% in the Fair Level category, while in the BP3, 28% were classified in the Excellent level and 72% in the Good level. In both watersheds, bridges and small bridges presented Excellent and Good levels, while in culverts the Good and Fair levels predominated, showing that the first structures created fewer impacts in the fluvial channels than the culverts. These data illustrate the great

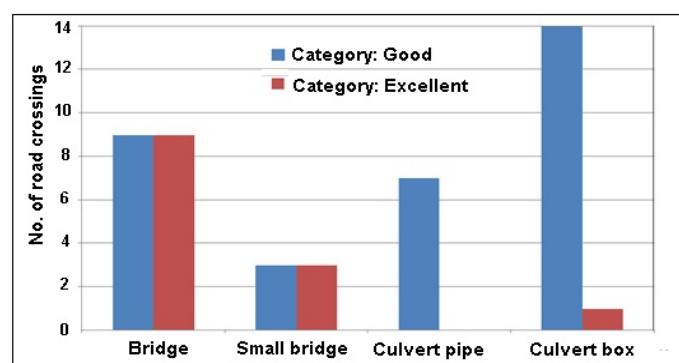
Figure 6. Comparison between the stability categories of fluvial channels and types of road crossings in the Parana Watershed 3.

The morphological and ecological impacts upstream and downstream of culverts pipe are greater than in culverts box [28]. In this study, this conclusion is corroborated by the lack of excellent levels in the culverts pipe surveyed (Figure 6), and by the finding that the devices with lower stability indexes are culverts pipe such as devices number 10, 16 and 45 (see Tables 4 and 5), which add up to 67, 70 and 67 points, respectively. It should be remembered that the Good level for channels with threshold-depression, flatbed and dunes ranges from 49 points (greater stability) to 84 points (lower stability) (Table 5).
