Complications and Problems of Penile Prosthetic Surgery in a Series of 530 Cases Operated on by the Same Surgeon in Italy

Abstract: Penile prosthetic surgery enables completely spontaneous penetrative sex and hence is the definitive solution for men with erectile dysfunction. Like all procedures requiring the insertion of exogenous material into the body, penile prosthetic surgery is associated with potentially serious complications, mainly due to infection or malfunction of the implant. While major complications may lead to the removal of the implant and thus the unfortunate failure of the surgeon's proposed treatment and disappointment of the patient's expectations, a number of more minor problems may arise which can be resolved without having to resort to removal. The author presents a variety of medical and surgical procedures, based on his more than 30 years (1984-2016) of experience of penile prosthetic surgery, which may be implemented to avoid implant failure.

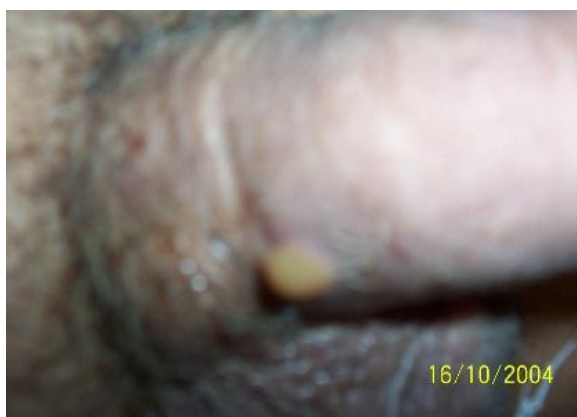
Patient, 58 years, received an AMS700 UltrexIPP under spinal anaesthesia in 1992. He was administered preoperative antibiotic therapy with ceftriaxoneICf and ciprofloxacin (Cp). 15 days after the procedure and before the implant had been used, the patient complained of high septic fever and pain at the base of the shaft. A yellowish boil was found at the base of the penis on the right, from which issued a creamy yellowish purulent fluid (Fig. 1).

Fig1. Purulent Infection with Cutaneous Fistula after 20 Days of Local Antibiotic Therapy

refused categorically. A solution of iodopovidone in saline was injected into the pericavernous space (Fig. 2) and the cylinders were inflated to flush the solution out 2-3 times. Gentamycin (Gm) was then instilled and kept in loco with the cylinders partly inflated.

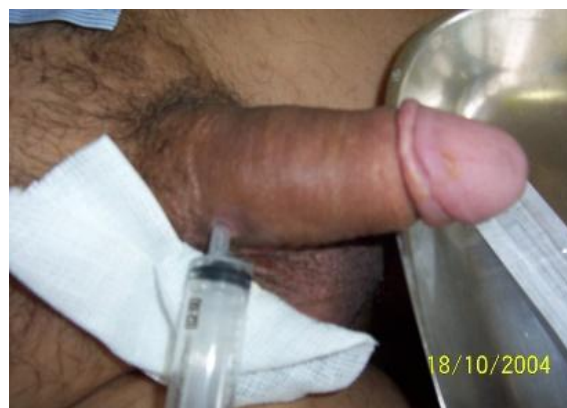
Fig2. Local Infusion of Betadine and Antibiotic Solution for Purulent Infection with Postoperative Cutaneous Fistula.

This procedure was performed every 8 hours for 7 days, and a progressive reduction in the volume and purulence of the secretion was observed. After 3 days Gm alone was injected, followed by the complete deflation of the implant cylinders. After 5 days no more pus was secreted and the Gm inoculation was stopped. The opening remained closed after 20 days (Fig. 3).

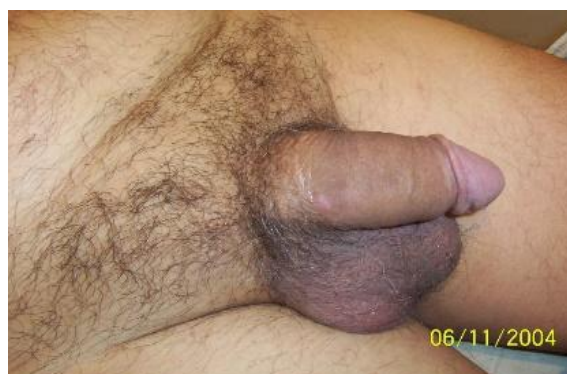
Fig3. Closure of the fistula after 20 days of local therapy

The cylinders were kept at maximum inflation. After another 4 days with no secretion, fever or pain, the cylinders were deflated. Since then the patient has had no further infections and has used the implant regularly from 1992 to date.

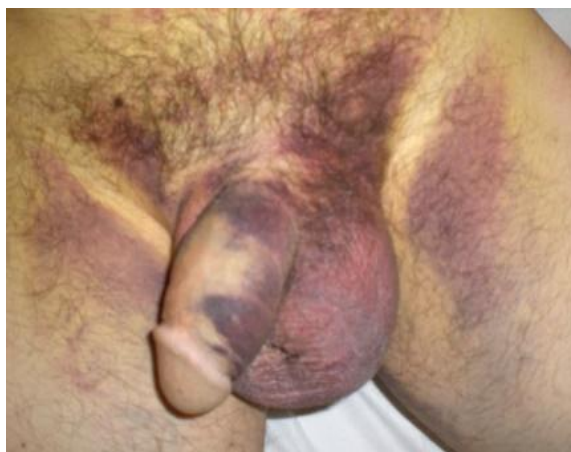
Patient, 31 years, with normal baseline coagulation parameters, underwent implantation of a Coloplast Genesis 11x22 cm implant via peno-scrotal access, without any particular difficulties. The following morning he presented a large ecchymosis involving the pelvic and genital area, without any hematoma (Fig.4).

Fig4. Diffuse Pelvic ecchymosis. No Surgical Treatment

The ecchymosis was successfully resolved through medical treatment and observation. A year later the same patient requested a Coloplast OTR IPP, as he was dissatisfied with the rigidity of the Genesis implant. Penoscrotal access was used, and there were no particular problems with the removal of the Genesis cylinders and insertion of the reservoir, in the retropubic space, and the inter-testicular pump. Closed suction drainage was used. During the night, a large hematoma appeared, involving the scrotal sac and shaft (Fig. 5);

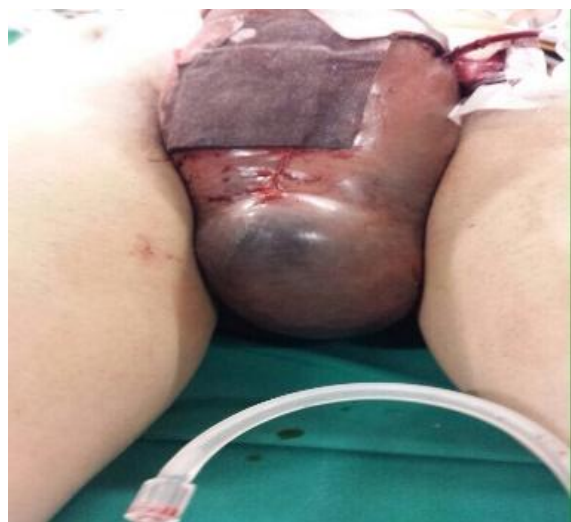
Fig5. Massive Scrotal hematoma made spite scrotal drainage (Coloplast Titan OTR). Surgical evacuation. Subsequent normal post-operative course

The drain was empty. An immediate exploratory procedure failed to identify the source of the bleeding. The area was flushed with antibiotic solution and a new suction drain positioned. The cylinders were kept fully inflated for two days. The drain, which was empty, was removed after 2 days and the cylinders were kept inflated for 5

days, until the first outpatient follow-up visit. The patient did not have any negative consequences. We referred the patient to a haematologist. Two years later he reported good penetrative activity.

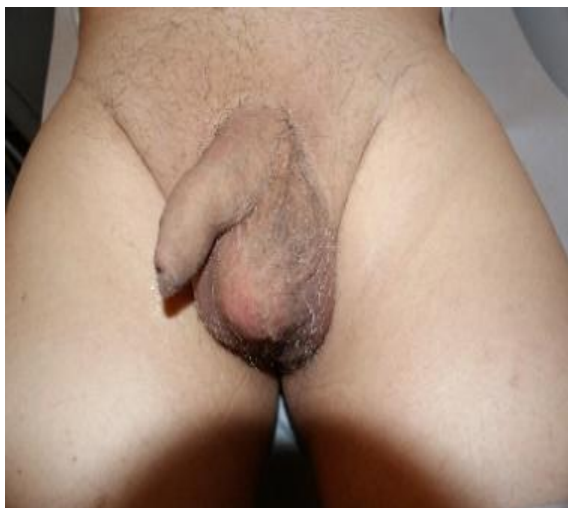
Patient, 63 years, heavy smoker, who had Peyronie's disease with shaft deviation. An AMS700 Ultrex was implanted in 2008 (peno-scrotal incision, inter-testicular pump, reservoir in retropubic space, Wilson's manoeuvre to correct the curvature, no aspiration and drainage). The patient was discharged the day after surgery. No complications were found at 3-day follow-up. After the first follow-up the patient did not leave himself time to recuperate and took numerous long car trips. After 5 days he complained that he could not find the scrotal pump due to progressively increased scrotal volume (Fig.6);

Fig6. *The Prosthetic Pump Surrounded by a Clear, Transparent Fluid with the Capsule Under Tension (Hydrocele)*

No fever or pain. At 21-day follow-up a collection of scrotal fluid was found which impeded location and activation of the pump. US examination revealed a homogeneous, non-corpuseular fluid. It was decided to operate (treatment with Cf and Cp; re-incision of the peno-scrotal wound). The prosthetic pump was found to be surrounded by a clear, transparent fluid with the capsule under tension. The fluid was drained and the capsule was removed; bleeding was controlled. After verifying pump function, aspiration and drainage was performed and the scrotum was sutured. The next day the drain was removed and the patient was

discharged. 15 days later the cylinder inflation-deflation process began, with easy identification and activation of the prosthetic pump. The patient then enjoyed intense sexual activity until 2017, when a new problem developed.

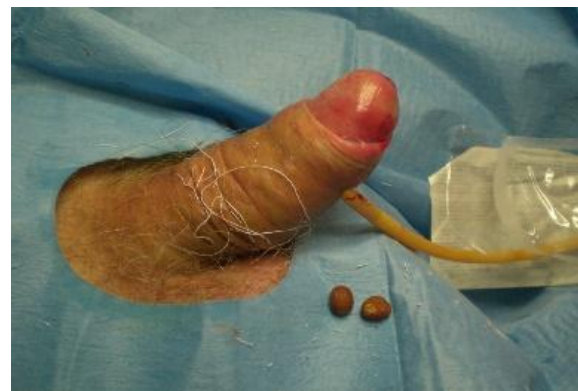
The same patient now aged 73 and under treatment for hypertension, hyperuricaemia and obstructive pulmonary disease, complained of an acute pelvic pain with an episode of gross haematuria. An abdominal US examination performed in another hospital excluded kidney stones but found that the prosthetic reservoir was adjacent to the bladder and there were hyperechoic images in the bladder. From the following morning the patient presented urinary retention and pain in the distal part of the urethra. He returned to the author's surgery, where it was found that the penile implant was functioning correctly and there were no problems with the reservoir. A bladder US examination did not reveal any obvious stones. Solid, roundish formations obstructing the urethral canal could be seen in the distal part of the urethra. A small meatotomy was performed under local anaesthetic with lidocaine cream and two stones, of 5-7 mm diameter, were extracted (Fig.7).

Fig7. *Urethral Stones Removed from a Pt. 9 Years after an AMS 700CX IPP*

A Foley CH16 catheter was inserted, which reached the bladder easily without encountering any obstructions. After 7 days of antibiotic therapy with Cp the patient underwent a flexible cystoscopy which revealed benign prostatic hyperplasia, detrusor hypertrophy and no bladder stones.

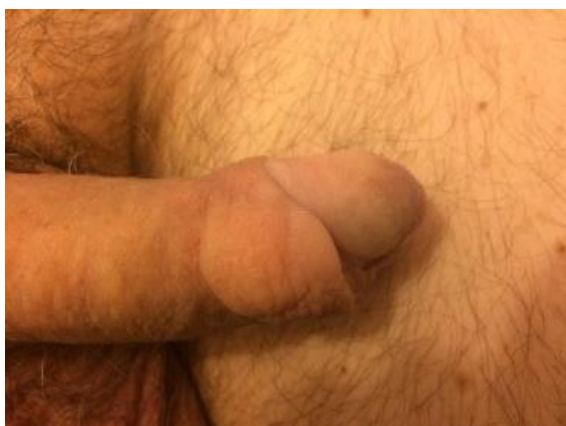
Patient, 52 years, arterial disease, with Coloplast Titan OTR implanted through the infra-pubic route. There were no problems during surgery. The patient developed a significant oedema of the foreskin 7-10 days after surgery. After 5 days the lymphoedema was still present and antibiotic and cortisone therapy were instigated. After 25 days the patient began using the implant. Five days later the foreskin oedema reappeared, creating problems with shaft rigidity. Cortisone therapy was recommenced, and the patient's condition normalised after 7 days. However, the foreskin lymphoedema returned (Fig.8) after his first sexual relations, tending to normalise after cortisone therapy. At this point a circumcision was performed, thus resolving the problem.

The infra-pubic incision could determine a blockage of local lymphatic drainage.

Fig8. Persistent for eskinlymphoedema 3 months after infra pubicincision

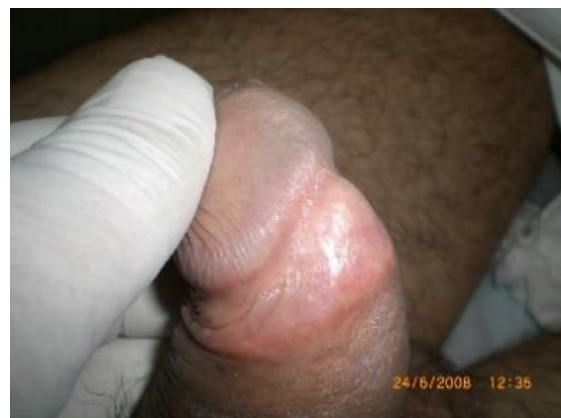
Patient, 56 years, with longstanding Peyronie's disease and erectile dysfunction. An AMS700 CXIPP, 18 cm long with +2.0 cm Rear Tip Extender (RTE) was inserted. After 6 months the patient complained of pain in the glans, which was deformed, due to suspected apical extrusion of the right cylinder (fig.9).

Fig9. Partial extrusion below the Glans of the Tip of an AMS 700 CX Cylinder

It was decided to perform exploratory surgery following antibiotic prophylaxis with Cf and Cp; this involved sub coronal incision,

separation of the glans and liberation of the tip of the right corpus cavernosum, which seemed to have been perforated by the cylinder. The cylinder had not reached the outside and therefore there was no reason to suspect bacterial contamination (Fig.10).

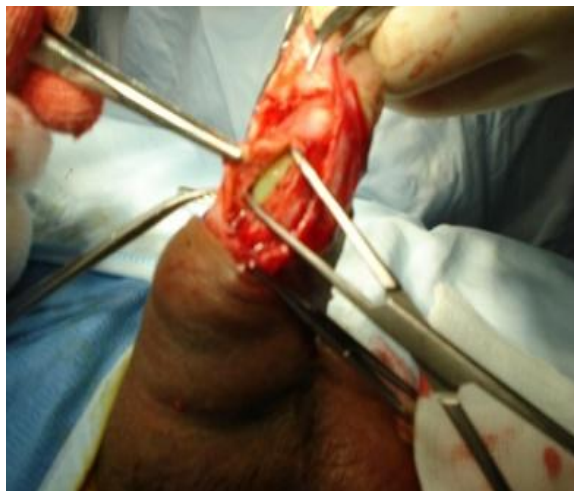
Fig10. *The Tip is detached from the Glans, the Cylinder is Removed, the RTE is Reduced, the Tip is Repaired and Sutured with a Small Marlex "Hood" Affixed over the Tip of the Corpus Cavernosum*

Following a small re-incision at the base on the right of the penis and incision of the tunica albuginea, the right cylinder was extracted and the 2.0 cm RTE was replaced with a 1.0 cm extender. The margins of the apical laceration were removed and the wound was sutured with Vicryl 2/0. A small Marlex patch for hernia repair was affixed as a "hood". The right cavernous cylinder was reinserted. After verifying that there was no apical tension, the glans was fixed above the tip of the corpus cavernosum. The cylinders were kept inflated for 5 days and then alternately inflated and deflated for several hours. After 25 days the patient was authorised to recommence penetrative sex. Seven years later, the patient is satisfied and performs regular penetrative sex.

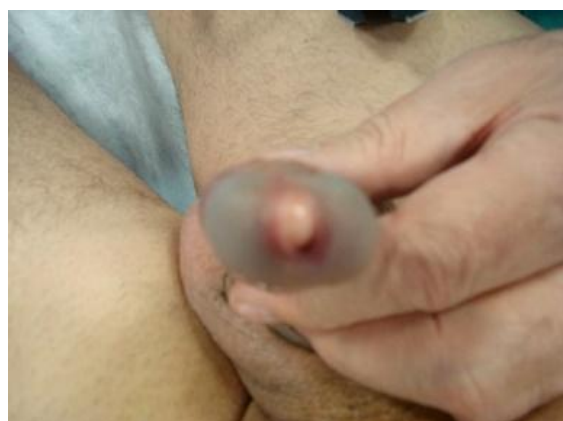
Fig11. *Initial Extrusion of Malleable Implantal Cylinder 8 Months after Implant (No Contamination)*

Surgery was performed to free the tip of the corpus cavernosum perforated by the cylinder, which was extracted, and the area was flushed with antibiotics. It was decided not to implant a new cylinder immediately due to the risk of infection. Aspiration and drainage was inserted

and removed after 2 days. After discharge, the patient reported that he had acceptable sexual relations with just one cylinder, and preferred not to undergo further surgery.

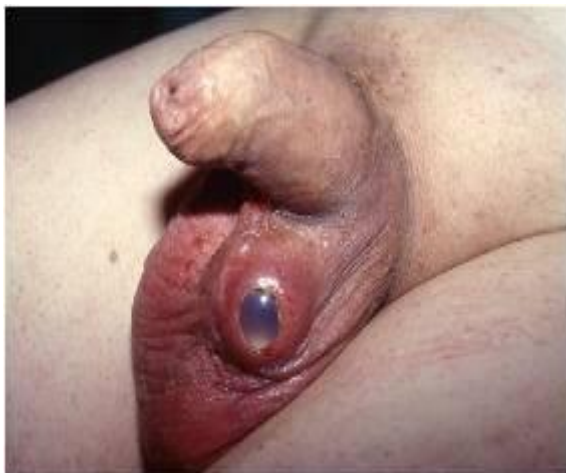
Two patients, 58 and 64 years, with diabetes and AMS700 Ultrex IPP, presented scrotal inflammation, purulent reaction, skin erosion and emergence of the prosthetic pump 30 and 36 days after the implant procedure (Fig.12).

Fig12. Scrotal Skin Erosion Following Scrotal Abscess in a Diabetic Patient which Developed 36 Days after AMS 700CX Implant

The patients' general and local condition led to the full removal of the implants. Neither patient wanted to undergo anew implantation procedure, due in part to financial motives (28, 29).

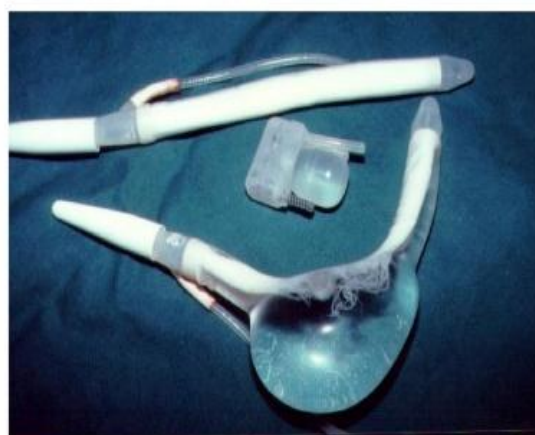
There are various "classic" complications which caused removal of the implant in this author's practice. Two distal extrusions were recorded with semi-rigid and malleable implants, but no case of significant infection. Mechanical breakdowns occurred in 14 of 18 single-component IPP(77.7%) and in 25 of 134 (Fig. 13,14)

Fig13. Aneurysmal Dilatation of an Ams700 Ultrex Cylinder. Removal

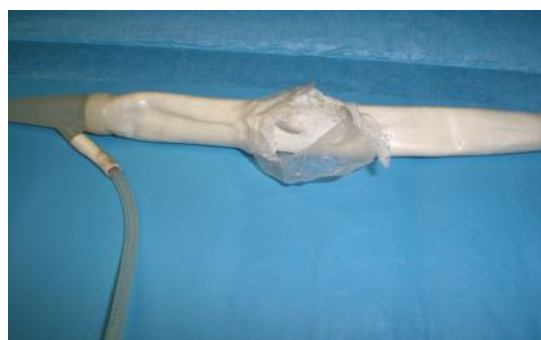
Fig14. Breakage of The Outer Sleeve of the AMS 700 Ultrex Cylinder. Removal

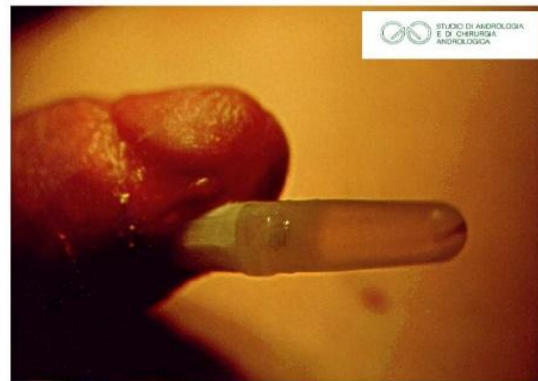
Many problems related to tissue reactions involving the implant's components (extrusion of the cylinders (Fig. 15) or tubes, pump malfunction, involvement of scrotal pumps in reactive and coagulation processes) can be resolved with a new, possibly limited surgical procedure, while bearing in mind the risk of causing further damage.

Fig15. *Extrusion of an AMS Hydroflex cylinder (contamination, removal)*
